## **LR Marine Consulting, LLC**

Inspection - Ascertain  
Condition and Valuation Survey  
for Pre-Purchase Only  
as of  
May 12, 2026

### **SURVEY REPORT NO.**

### **DROP SPUD BARGE ‘**

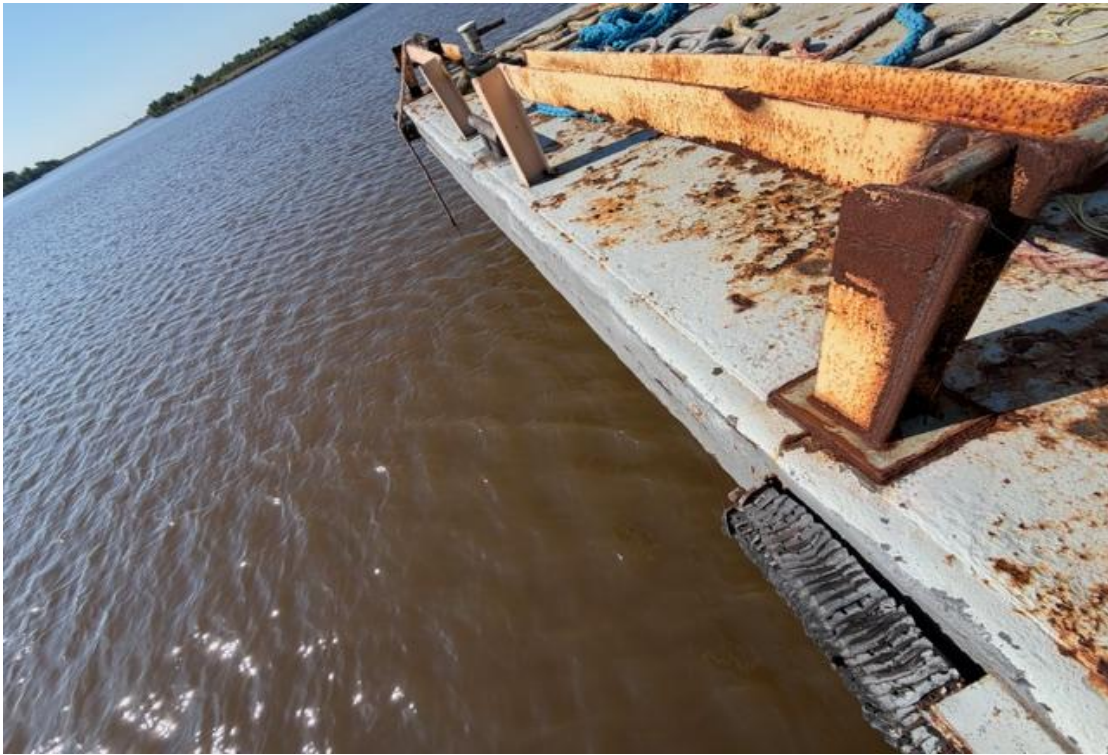
**VIEW OF BOW RAKE AND HEADLOG**

- bow rake plating was difficult to sight due to the moored position at the time of survey; however, internals were sighted.
  - headlog plating was sighted from the deck.
- headlog plating contains numerous 0 – ¾" indents throughout.
- headlog plating contains moderate pitting, scrapes, and rust/scale throughout.
- headlog plating contains moderate washboarding throughout.
  - internal framing outlined in way.
- port and starboard corner wrappers and rake knuckles contain mild to moderate distortions throughout.
- headlog plating set in 0 – 2" over an area of 10" x 5", located 3' to port of centerline.

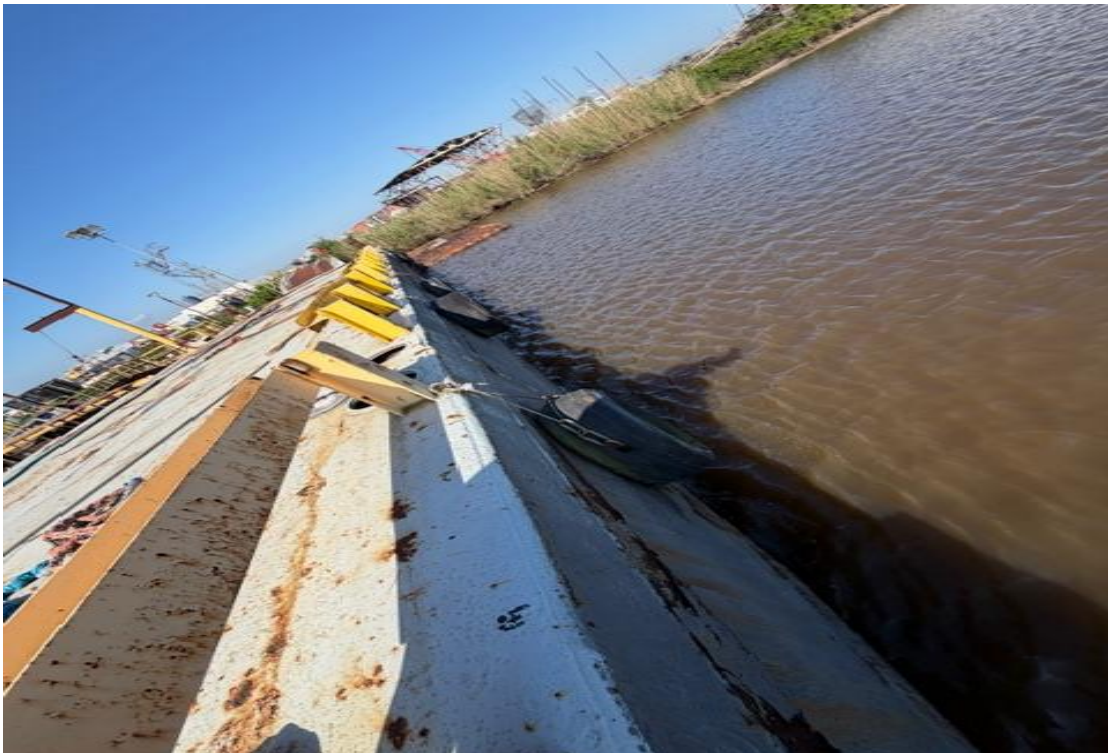
**VIEW OF PORT SIDE**

- side plating contains random 0 – 3/4" indents throughout.
- side plating contains moderate washboarding, pitting, rust/scale, and scrapes throughout.
- side plating set in 0 – 1" over an area of 8" x 5", located in way of port number 1 main compartment manhole.

- deck plating and deck gunnel affected in way.
- side plating set in 0 – 1" over an area 4' x 3', located 3' aft of the port number 1 main compartment manhole.

- side plating set in 0 – 2" over an area of 5' x 3', located in way of kevel number 1.
- side plating set in 0 – 2" over an area of 6' x 4', located 10' aft of kevel number 1.

- side plating set in 0 – 2" over an area of 6' x its full height, located in way of the port number 2 main compartment manhole.
- side plating set in 0 – 1" over an area of 3' x 3', located in way of kevel number 2.

- side plating set in 0 – 1" over an area of 5' x 2', located 5' aft of kevel number 2.

- side plating set in 0 – 3” over an area of 12” x 5”, located 8’ aft of kevel number 2.
  - deck plating and deck gunnel affected in way.
- side plating set in 0 – 4” over an area of 6’ x 4’, located 6’ forward of kevel number 3.
- side plating set in 0 – 2” over an area of 5’ x 3’, located in way of kevel number 3.
- side plating set in 0 – 3” over an area of 6’ x its full height, located 4’ aft of kevel number 3.
  - deck plating and deck gunnel affected in way.

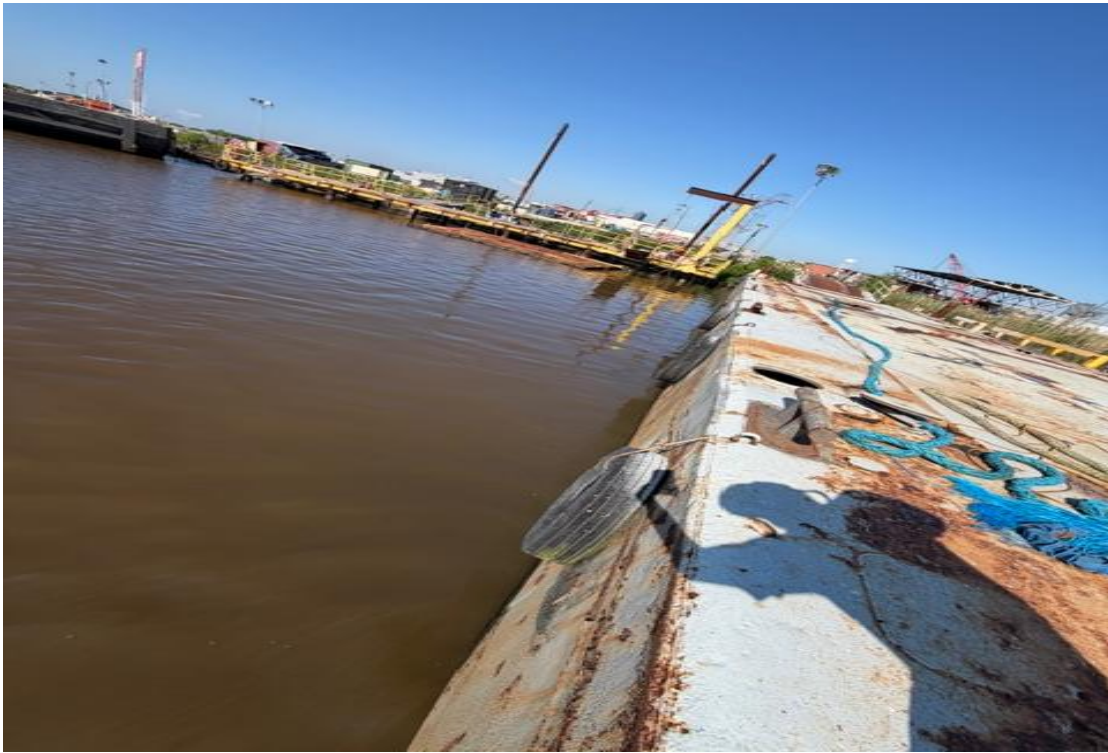
**VIEW OF STARBOARD SIDE**

- side plating contains numerous random 0 – ¾" indents throughout.
- side plating contains moderate washboarding, pitting, scrapes and rust/scale throughout.

- side plating set in 0 – 2" over an area of 3' x its full height, located 3' aft of the bow double bitts.
  - deck plating and deck gunnel affected in way.

- side plating set in 0 – 3" over an area of 18' x its full height, located 5' aft of the bow double bitts, extending aft.
  - deck plating and deck gunnel affected in way.

- side plating set in 0 – 2" over an area of 4' x 3', located in way of tire number 3.
  - deck plating and deck gunnel affected in way.
- side plating set in 0 – 3" over an area of 5' x its full height, located 3' aft of kevel number 3.

- deck plating and deck gunnel affected in way.
- side plating set in 0 – 2" over an area of 3' x its full height, located 8' forward of kevel number 4.

- side plating set in sharp 0 – 3" over an area of 2' x 1', located just aft of kevel number 4.
  - deck plating and deck gunnel affected in way.

- side plating set in 0 – 3" over an area of 6' x 3', located in way of the stern rake compartment manhole.
- side plating set in 0 – 3" over an area of 5' x its full height, located in way of the stern double bitts.

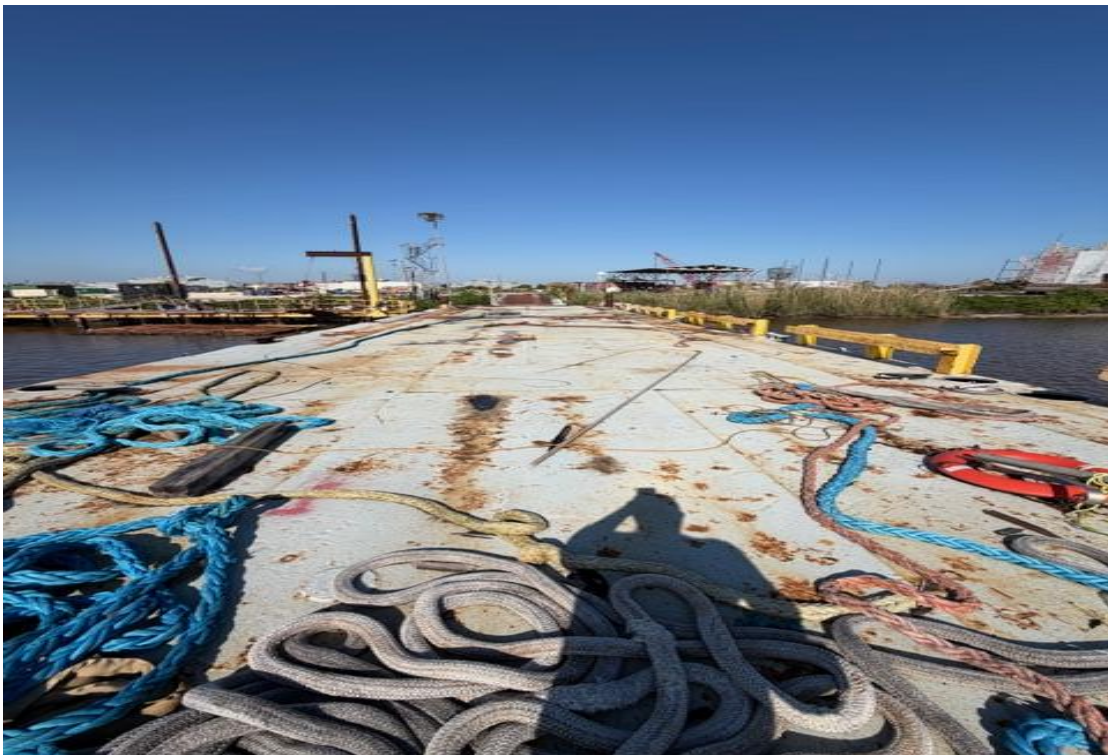
**OVERALL VIEW OF DECK LOOKING AFT**

- deck plating contains moderate washboarding, pitting, scrapes, and rust/scale throughout.
- deck plating contains numerous doublers, gouges, weld remnants, and weld scars throughout.
- deck plating contains numerous lengths of rope lying adrift.
- kevels:
  - starboard No. 1 is mildly bowed inboard.
  - starboard No. 2 is mildly bowed outboard.
  - starboard No. 3 has its aft horn mildly set down.

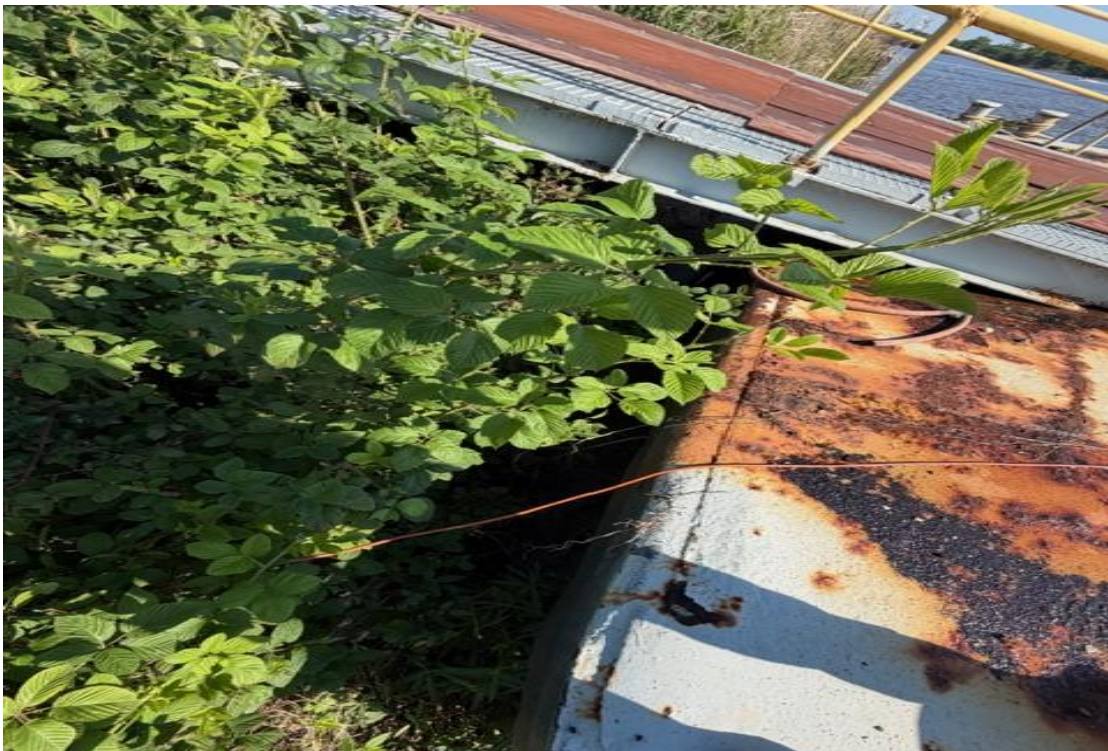
**VIEW OF STERN RAKE AND STERNLOG**

- stern rake and sternlog plating were difficult to sight due to the barge ramp and vegetation at the time of survey; however, internals were sighted.
- sternlog plating, where sighted, contains random 0 – 3/4" indents throughout.
- sternlog plating, where sighted, contains moderate washboarding, pitting, rust/scale, and scrapes throughout.

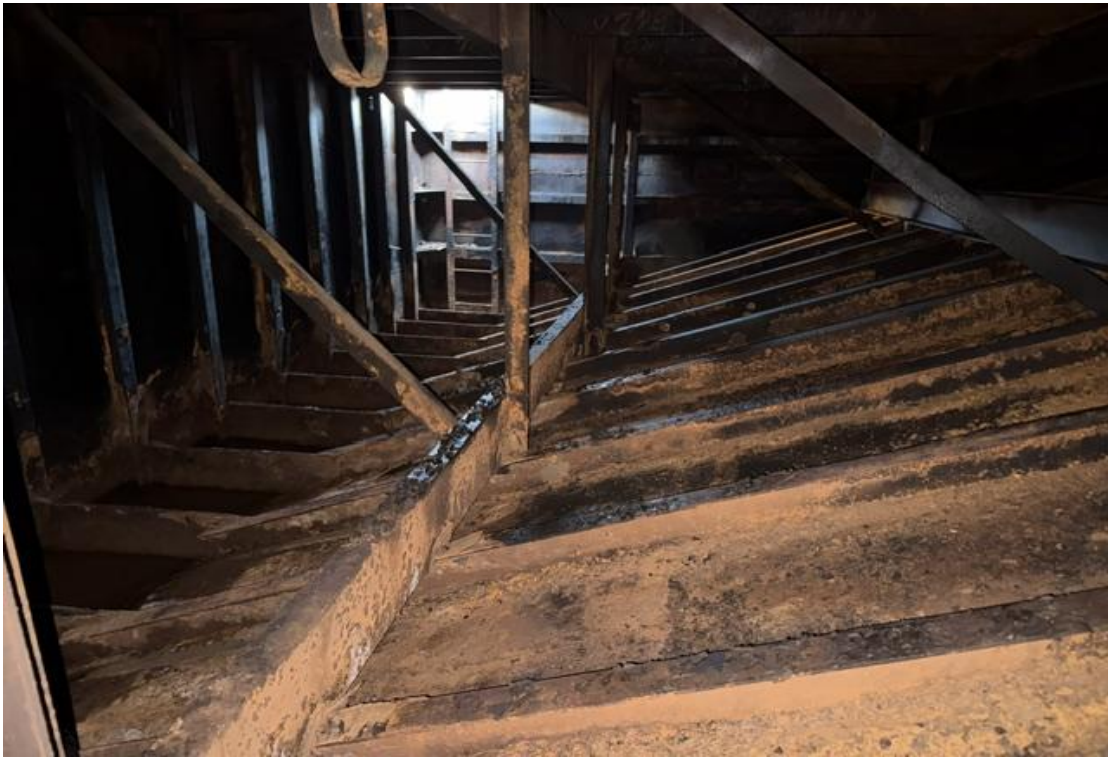
**BOW RAKE COMPARTMENT**

- compartment contains 2" of water.
- salinity level is 0 ppt.
- compartment contains mild amounts of silt/mud
- compartment contains moderate rust/scale throughout.

- coating is 35% intact.
- rake plating contains moderate distortions throughout.
- port forward corner bracket moderately distorted.
- forward horizontal stiffener moderately distorted throughout.

- port vertical stiffener number 1 moderately bowed.
- bottom longitudinals mildly bowed throughout.
- port side longitudinal number 1 moderately bowed and contains a fractured weld at vertical chords numbered 1 and 2.

- starboard side longitudinal number 3 contains a broken weld in bay number 2.
- diagonal stiffeners numbered 1 through 3 moderately bowed in bay numbered 2 and 3.

- starboard longitudinals numbered 2 and 3 moderately bowed in bay number 3.
- starboard aft corner brackets numbered 3 and 4 moderately distorted.
- aft bottom brackets numbered 7 through 9 moderately distorted.

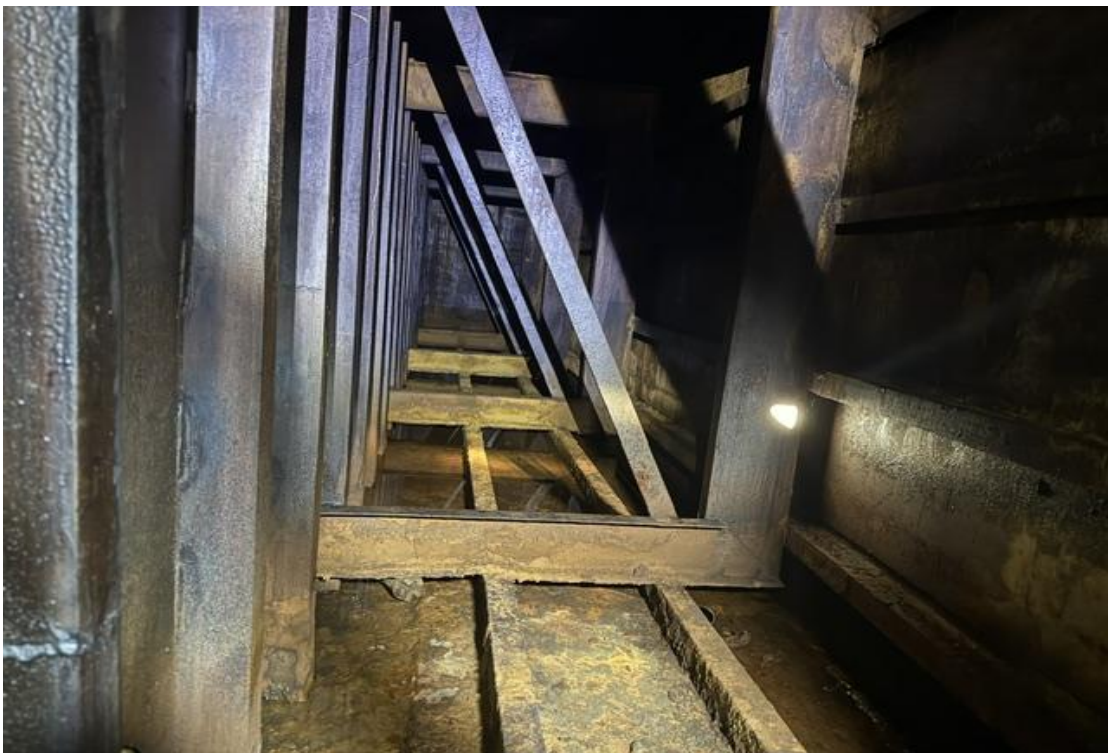
**PORT NO. 1 COMPARTMENT**

- compartment contains traces of water.
- salinity level is 0 ppt.
- compartment contains moderate amounts of silt/mud, rust/scale, and wastage throughout.
- coating is 10% intact.
- compartment contains a longitudinal swash bulkhead.
- side longitudinal number 4 welded is on with brackets.

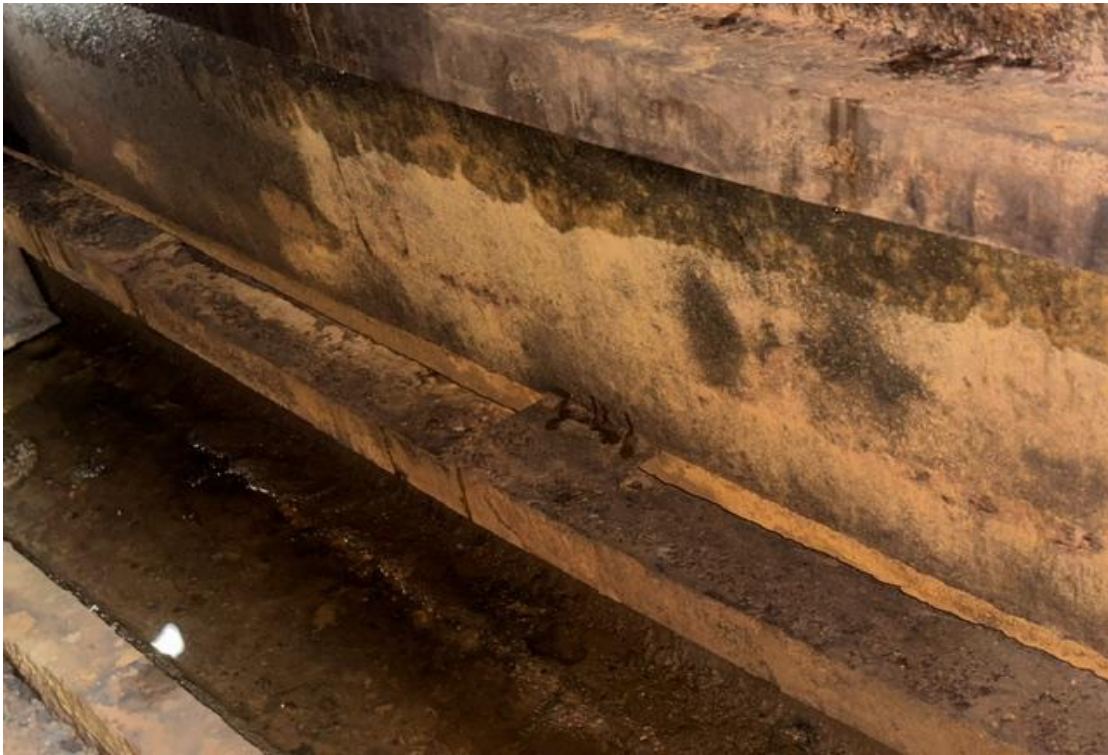
**SIDE LONGITUDIANL NO. 4 WELDED TO BRACKETS NOT PLATING**

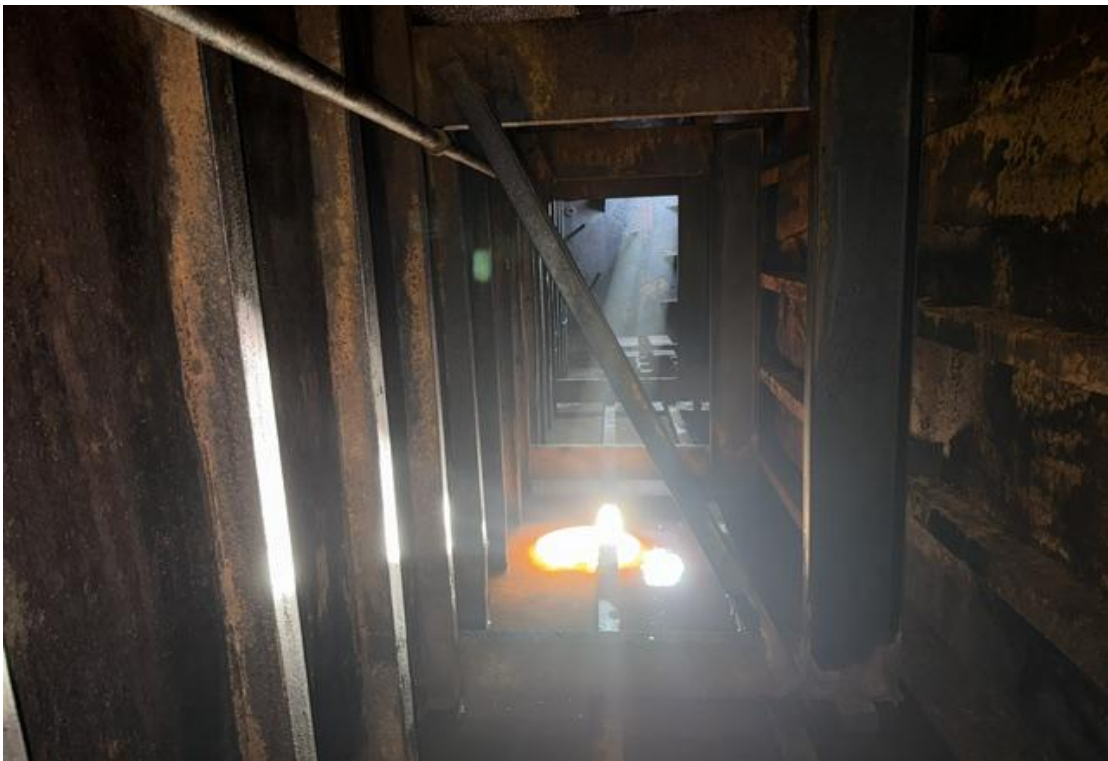
**STARBOARD NO. 1 COMPARTMENT**

- compartment contains 1" of water.
- salinity level is 0 ppt.
- compartment contains moderate amounts of silt/mud and rust/scale throughout.
- **CAUTION:** compartment is void of an access ladder.
  - surveyor had to climb side longitudinals to sight.
- coating is 50% intact.
- compartment contains a longitudinal swash bulkhead.
- bottom plating contains moderate rust blistering throughout.
- side longitudinals numbered 2 and 3 moderately bowed in bay number 1.
- side longitudinal number 1 moderately bowed in bay number 3.
- side chords numbered 1 and 2 moderately bowed in bay number 4.
- side longitudinals numbered 1 through 4 moderately bowed in the aft bay.

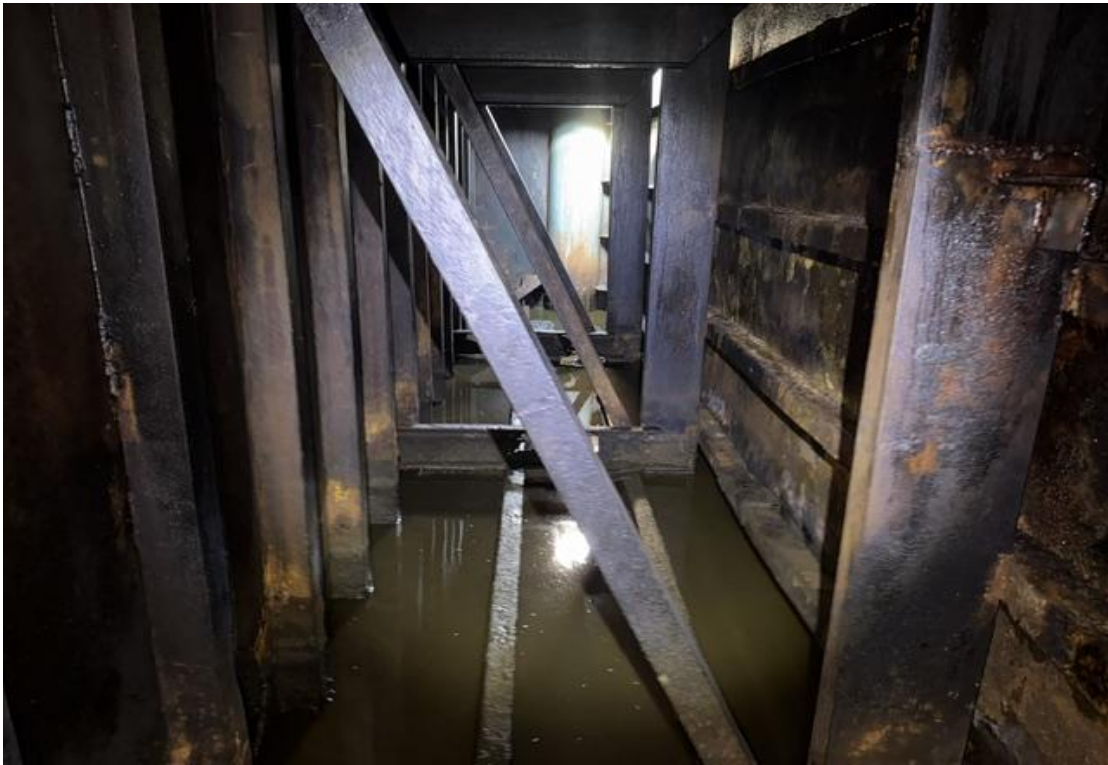
**PORT NO. 2 COMPARTMENT**

- compartment contains 4" of water.
- salinity level is 3 ppt.
- compartment contains moderate to heavy amounts of silt/mud.
- coating is 10% intact.
- compartment contains a longitudinal swash bulkhead.
- side longitudinals mildly bowed throughout.
  - side longitudinal number 4 is welded on with brackets.
- bottom longitudinals numbered 1 and 2 contain moderate wastage throughout.
- bottom chords numbered 3 through 5 contain heavy wastage throughout.
- side longitudinals numbered 3 and 4 moderately to heavily bowed in bays numbered 4 and 5.

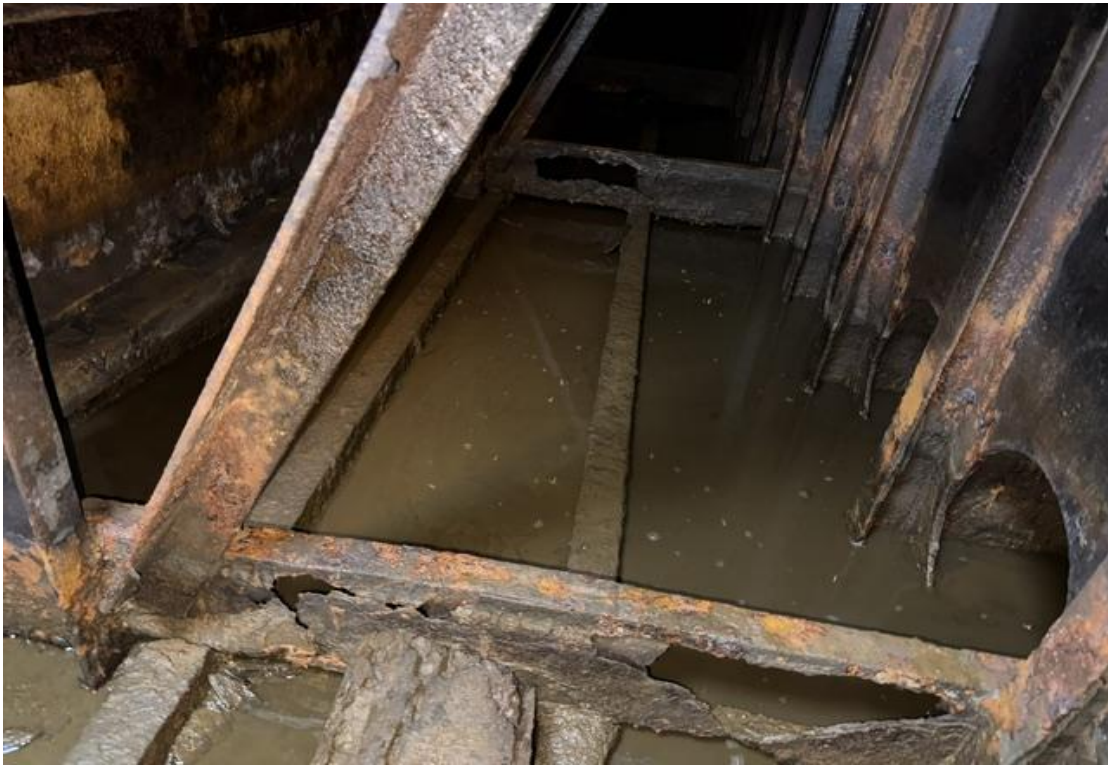
**PORT NO. 2 CONTAINS HEAVY WASTAGE**

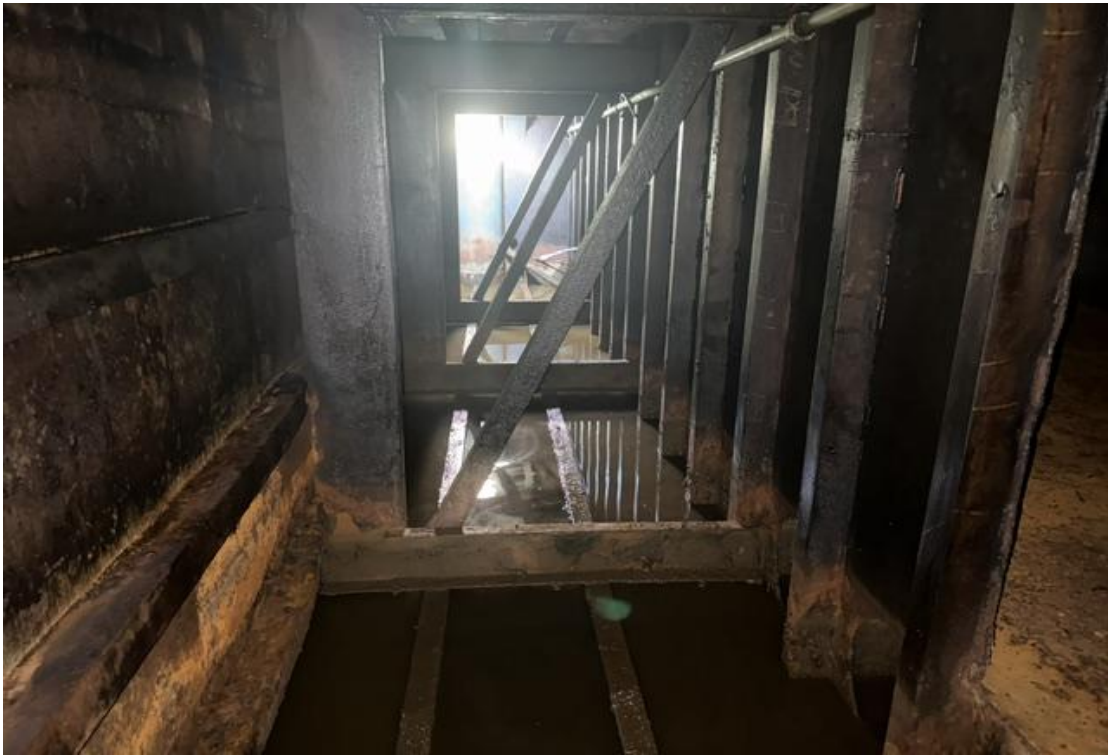
**STARBOARD NO. 2 COMAPRTMENT**

- compartment contains 3" of water.
- salinity level is 0 ppt.
- compartment contains mild amounts of silt/mud.
- coating is 50% intact.
- compartment contains a longitudinal swash bulkhead.
- side longitudinals numbered 1 through 3 moderately bowed in bay number 1.
  - corner brackets affected in way.
- vertical chords numbered 1 through 3 moderately distorted and contain broken welds at side longitudinal number 1.
- vertical chords numbered 4 and 5 contain broken welds at all side longitudinals.
- side longitudinals numbered 1 through 4 moderately distorted and bowed at random locations throughout.
  - side longitudinal number 4 is welded on with brackets.
- deck gunnel contains a pinhole, located midway in bay number 4.
- bottom longitudinal number 2 contains a split in the aft bay.

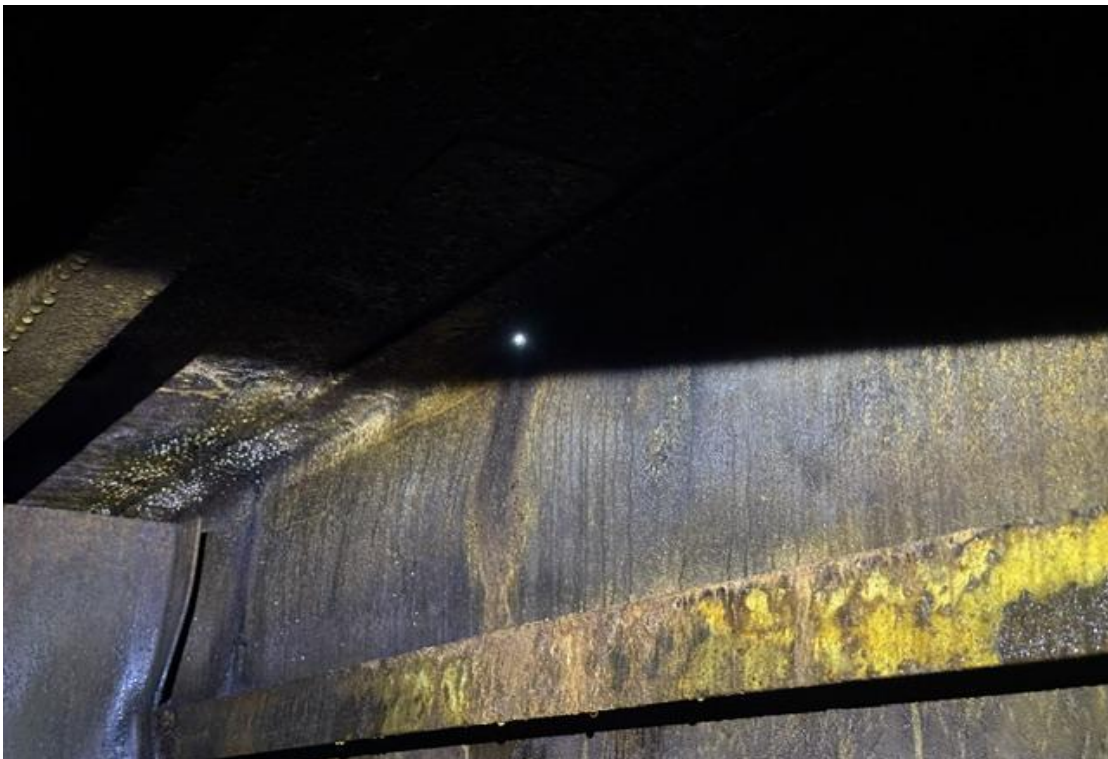
**STARBOARD NO. 2 COMPARTMENT WITH PIN HOLE**

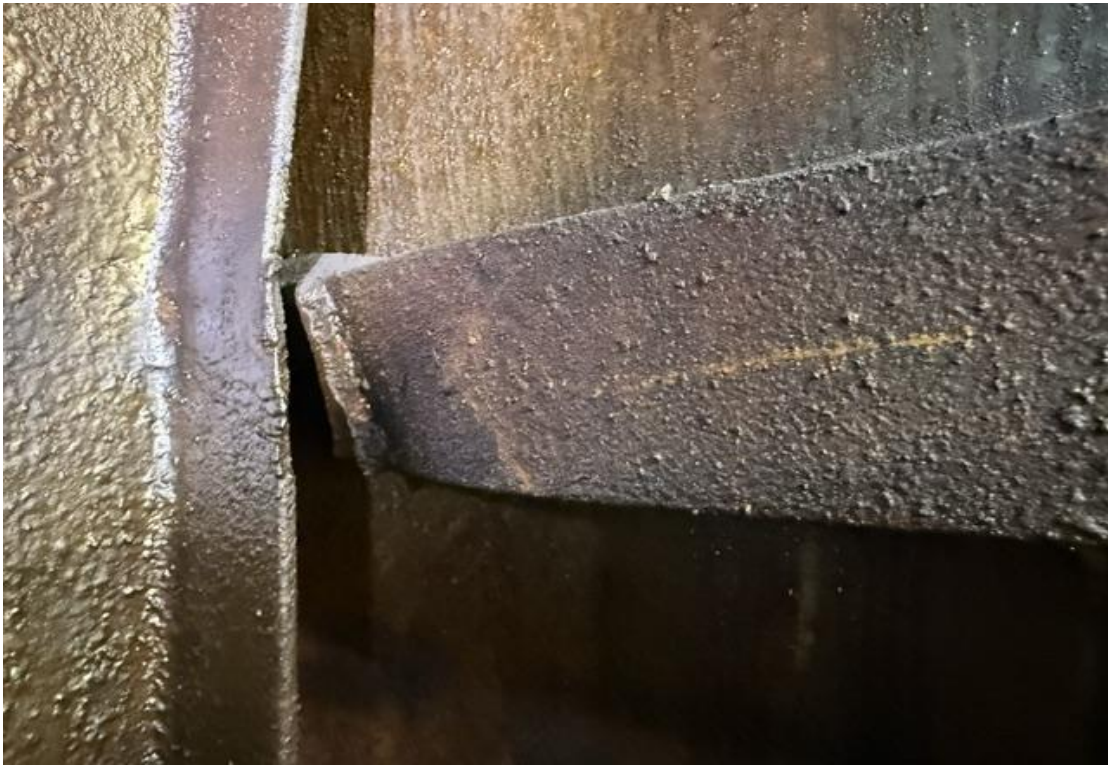
**STARBOARD NO. 2 CONPARTMENT  
SIDE LONGITUDINAL WITH BROKEN WELD AT CHORD**

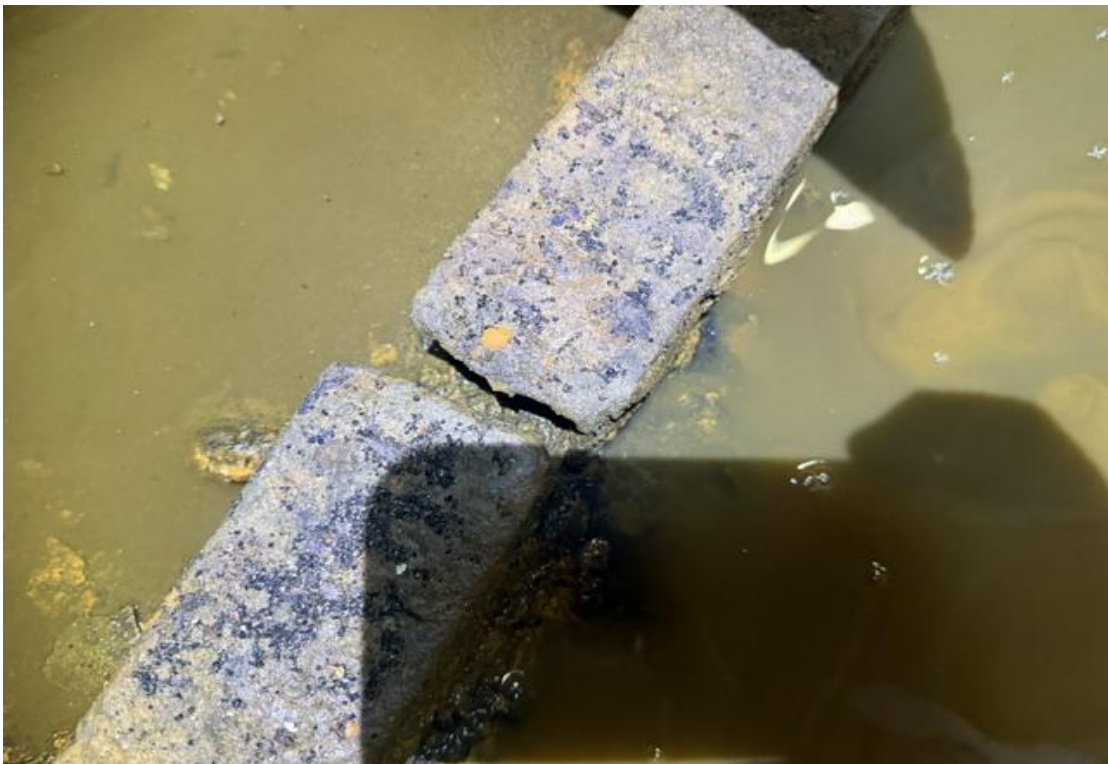
**STARBOARD NO. 2 COMPARTMENT BOTTOM LONGITUDINAL SPLIT**

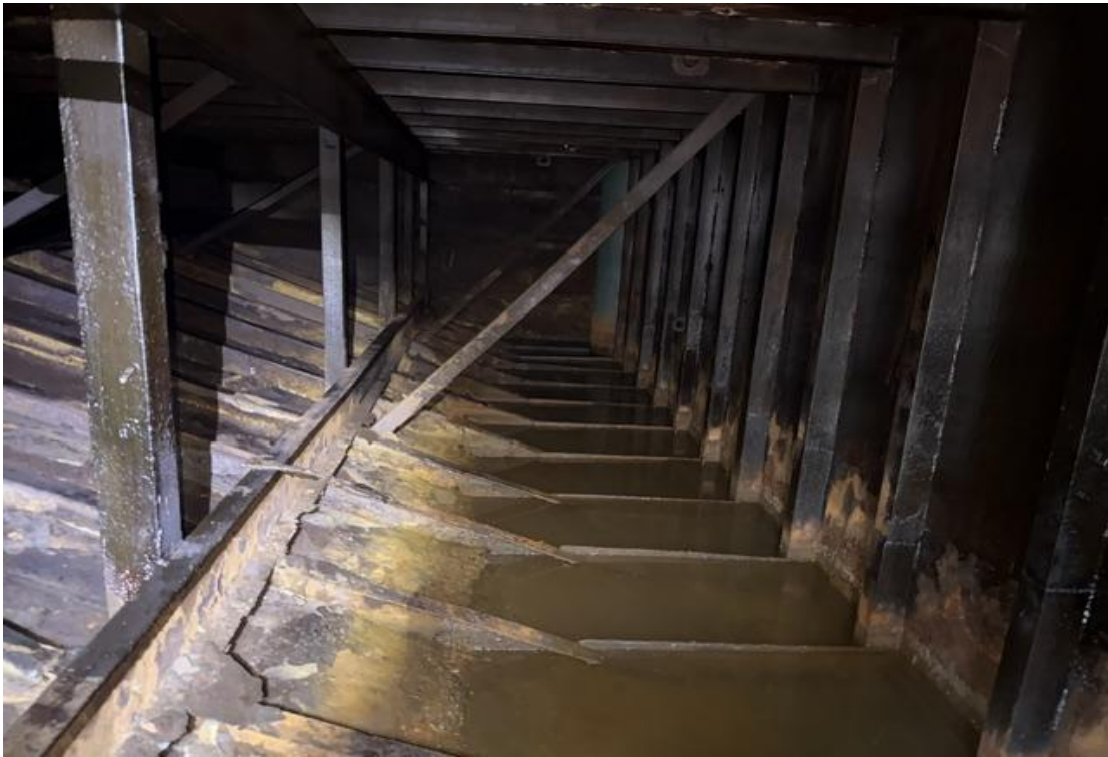
**STERN RAKE COMPARTMENT**

- compartment contains 12" of water.
- salinity level is 0 ppt.
- compartment contains moderate amounts of silt/mud and wastage throughout.
- compartment contains heavy rust/scale throughout.

- coating is 40% intact.
- port forward corner bracket number 3 moderately distorted.
- horizontal transverse stiffeners moderately distorted.
- starboard forward corner bracket moderately distorted.

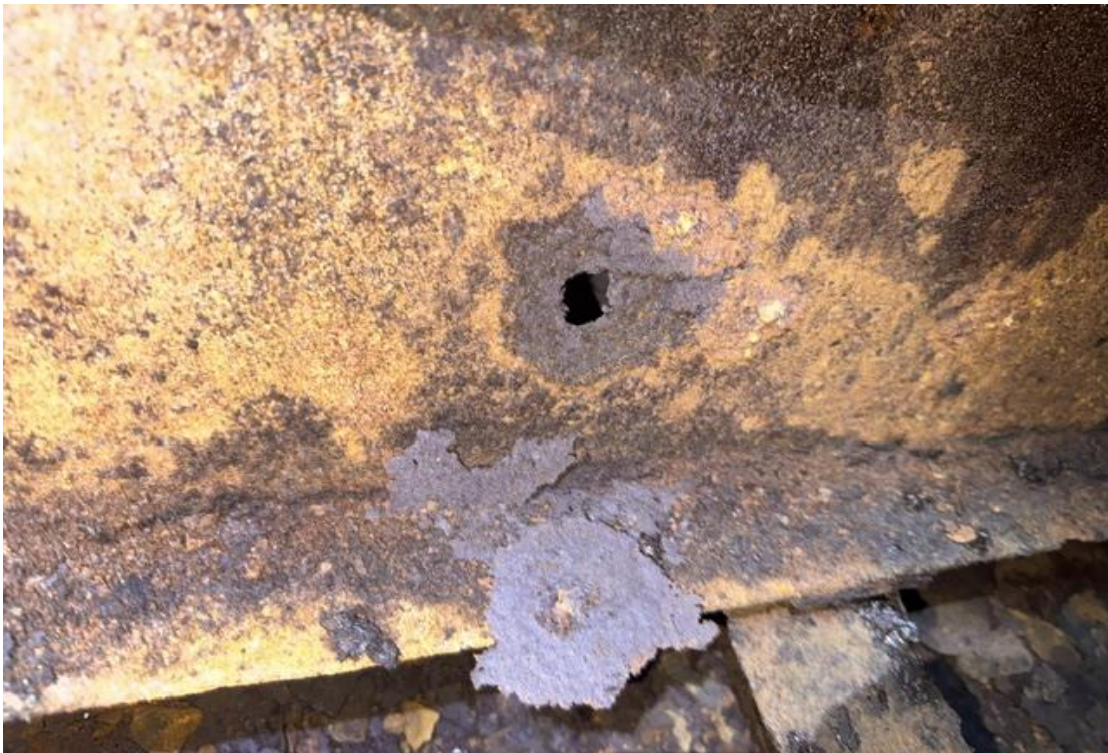
- starboard side longitudinal number 3 moderately wasted at forward corner bracket.
- bottom chord number 1 mildly wasted.
- port side longitudinals numbered 1 through 3 moderately bowed in bay number 1.

**STERN RAKE COMPARTMENT BOTTOM CHORD WITH WASTAGE**

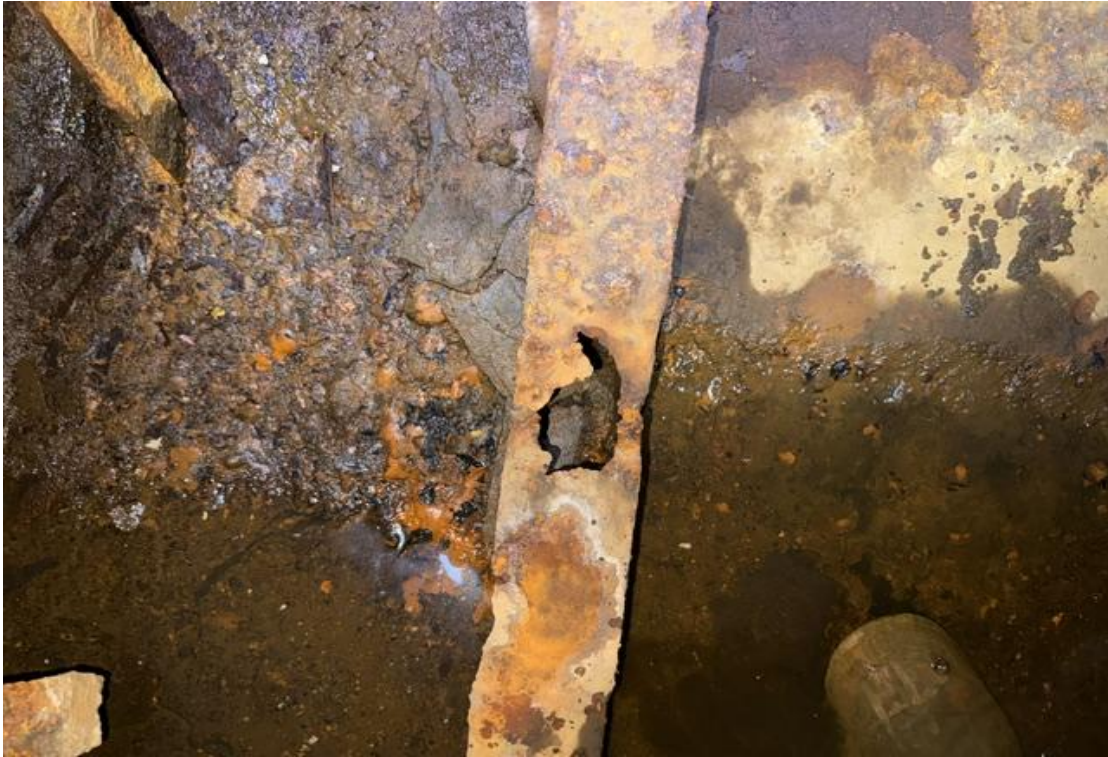
- starboard side longitudinal number 1 heavily wasted in bay number 1.
- starboard bottom longitudinal number 1 moderately wasted in bay number 1.
- port side longitudinal number 1 moderately bowed and contains a broken weld at vertical chords numbered 1 and 2 in bay number 2.

**STERN RAKE COMPARTMENT BOTTOM LONGITUDINAL WITH WASTAGE**

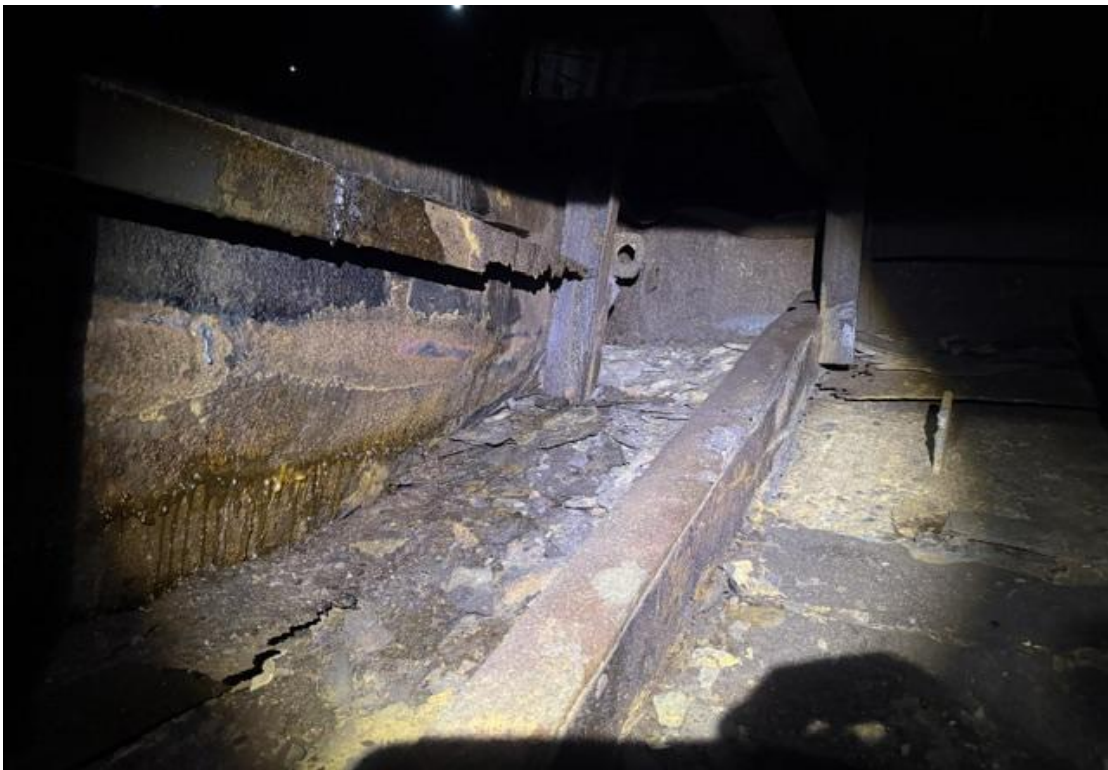
**STERN RAKE COMPARTMENT SIDE LONGITUDINAL WITH WASTAGE**

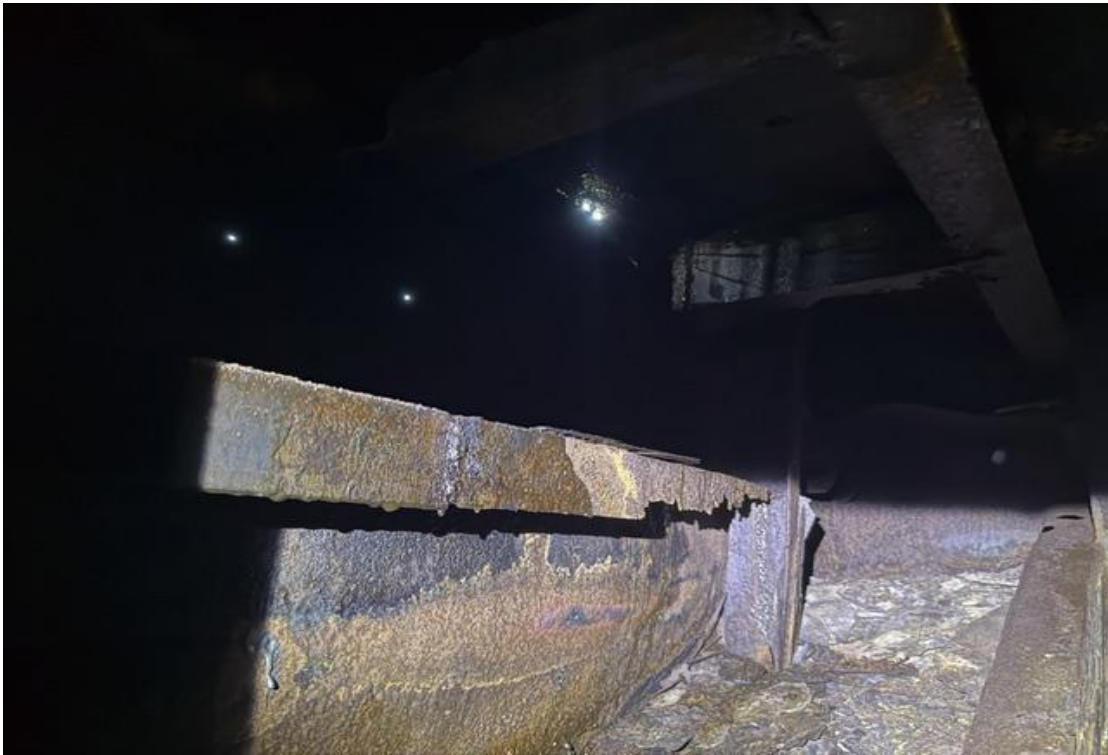
- vertical chord number 1 moderately distorted in way.
- starboard side plating contains four (4) pin holes in bay number 3.

**STERN RAKE COMPARTMENT  
STARBOARD SIDE PLATING CONTAINS HOLES**
