Twin Disc 518-1 Marine Gear - 5.92

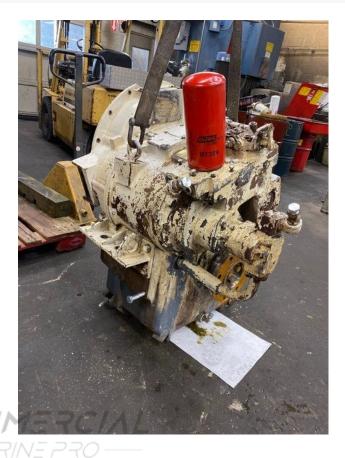
SAE #0 Rubber Block Drive The customer had said it had a bad oil cooler while out fishing and was full of water and he drained gallons out. Says he put new oil in and came home. When shop looked at the gear although there was a little rust on some surfaces, they saw no current signs of water and the oil cooler tested good. Because the customer runs a first class operation shop removed the gear from the boat, split the cases and looked inside the gear and saw a small spot of flaking on one of the pinions. Everything else inside the gear looked good.

Condition RTO
