Twin Disc 518-1 Marine Gear - 5.92

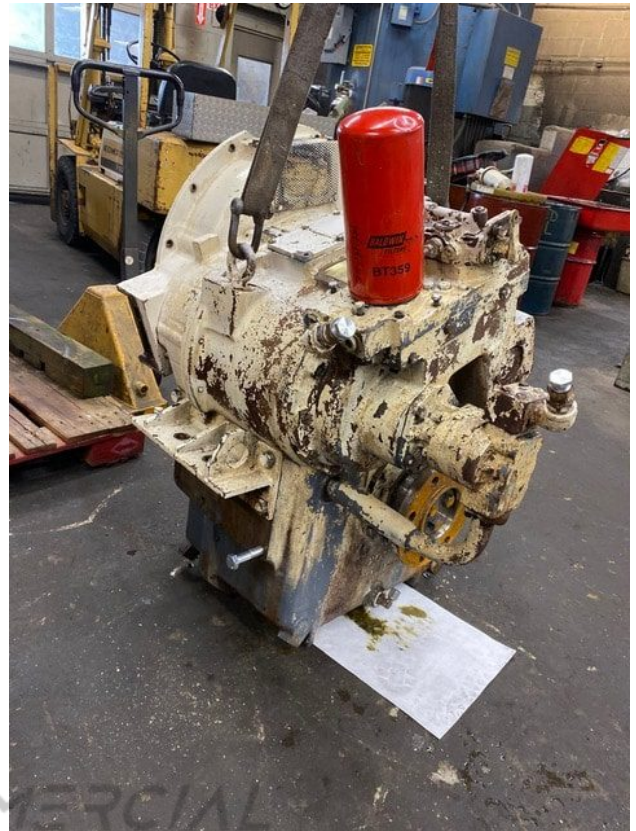
SAE #0 Rubber Block Drive The customer had said it had a bad oil cooler while out fishing and was full of water and he drained gallons out. Says he put new oil in and came home. When shop looked at the gear although there was a little rust on some surfaces, they saw no current signs of water and the oil cooler tested good. Because the customer runs a first class operation shop removed the gear from the boat, split the cases and looked inside the gear and saw a small spot of flaking on one of the pinions. Everything else inside the gear looked good.
