CAT 399 Marine Engine - RTO

PRODUCT DESCRIPTION

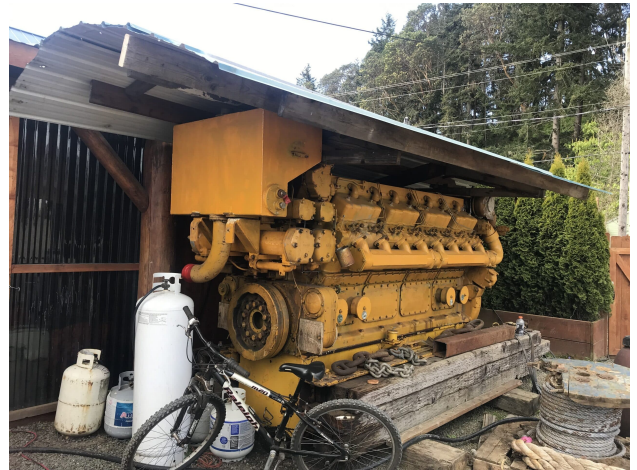
Serial: 35B673 23,000 hours Standard Rotation. Lef Hand Counter Clockwise. Engine ran fine, had good compression, minimal blow by, but was using coolant. One head was removed and tested fine. This led us to believe that one cylinder has counter bore issues. We removed the entire engine without any further investigation because we had another engine on hand. It has the bronze aftercooler for raw water after cooling and high HP.

Additional Information It has a counter bore issues. needs an insert. Crankshaft is 0.025 under. owner was told it has been ground one time. Crank is in excellent condition. Believed to have the extra large pan. 140 gal of lube. Fan when removed, but used water.
